CONNECTICUT RIVER BASIN
WEST HARTFORD, CONNECTICUT

**BUGBEE RESERVOIR DAM
CT 00491**

**PHASE I INSPECTION REPORT
NATIONAL DAM INSPECTION PROGRAM**

JUNE 1981

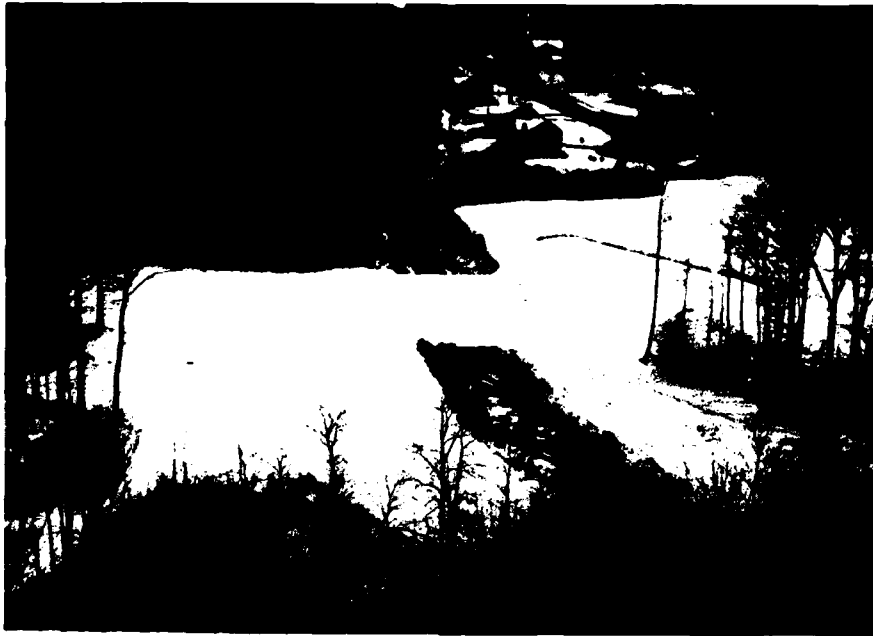
The dam is a grass covered, earthfill embankment with a foundation drain trench underlying the downstream slope. As shown in Photos 1 and 2, the alignment appeared good with no signs of vertical or horizontal movement. There was no evidence of any erosion on the dam embankment which was covered with a two to three inch layer of snow. Minor rutting was observed along the crest of the dam indicating some vehicular trespassing.

Photo 1 - View looking east along
the upstream side of the
dam embankment

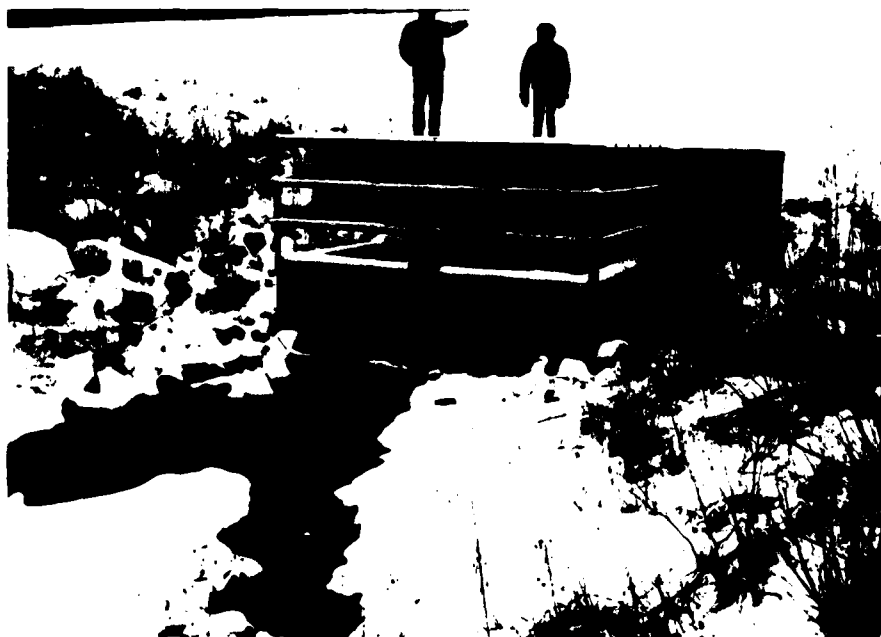
Photo 4 - Principal Spillway -
Intake Riser

3. A comprehensive program of inspection by a registered professional engineer qualified in dam inspection should be instituted on a biennial basis.
4. Remove the pile of rip-rap situated in front of the trash rack at the low level inlet at the intake riser.
5. Repair and paint metal safety mesh cover on top of the impact basin.
